INSTRUMENTATION AND EVALUATION OF DISTRICT 10 CALTRANS AUTOMATED WARNING SYSTEM (CAWS)

Technical and Operational Assessment

Prepared for the California Dept. of Transportation and California Office of Traffic Safety
by Loragen Corporation, San Luis Obispo, California

Document No. L-D10-FR-03

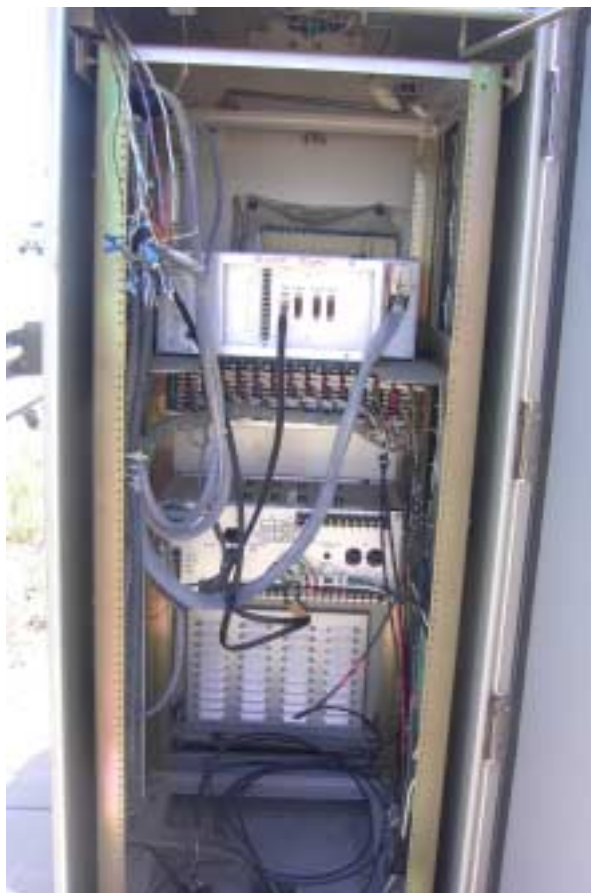
Figure 3.2.3.1. Inside of Type 334c control cabinet containing CAWS traffic monitoring equipment.

In our inspection of most of the cabinets of the CAWS, we found the wiring to be neat and well-labeled, and all components in each cabinet installed consistently. The one exception was the phone circuit wiring into some of the cabinets, which can be seen at the top right of Figure 3.2.3.1. This was inconsistent, and in several cases, we noticed that the circuit shields had not been grounded at the cabinet. While the circuits may have been grounded back at the demarcation box, possibly several thousand feet away, the lack of a local ground can cause serious noise problems when terminated at the 170 modem.

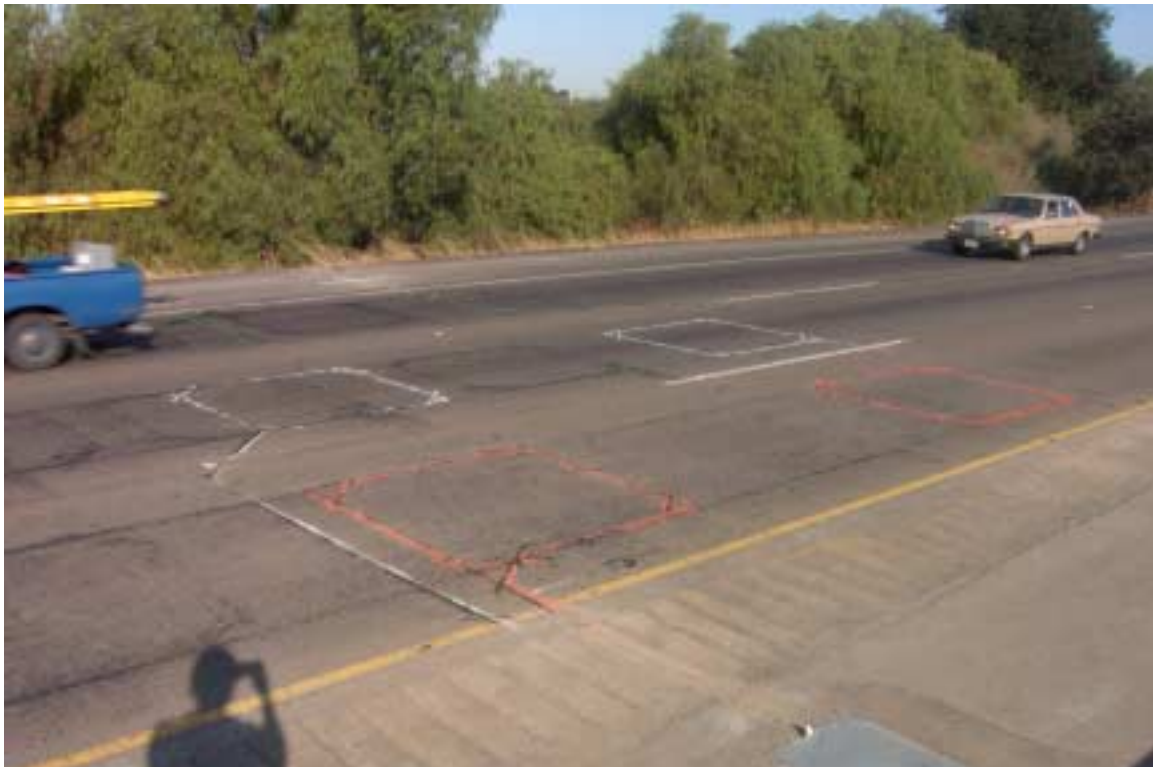
The sole speed measurement mechanism used in the CAWS are duplex inductive loops installed in each lane. Site monitored between one and five lanes, with three being the norm on I-5. A total of 216 inductive loops are connected to the CAWS. 8'x8' rectangular loops are used, as highlighted in Figure 3.2.3.2. The usual separation of the duplex loops is 20 feet, although variations from 16 to 30 feet were observed at various locations in the CAWS. It was not possible to verify if the loop separation distances has been correctly calibrated at individual traffic monitoring sites. However, speeds reported by the TMS computer as recorded in the TMS log files usually seemed reasonable. At the French Camp Slough count station that we used as a Before-CMS monitoring site, the loops had been incorrectly connected in series and the separation distance was much different than had been assumed (16 feet).

Figure 3.2.3.2. Duplex inductive loops installed in each lane for speed measurement at each traffic monitoring station.

In our experience during this study, the loop detectors were the most problematic of all sensors, both for the evaluation system and the CAWS itself. Loops were found to be susceptible to occasional false triggering from adjacent lanes, or failures to trigger. Sensitivities were usually set to 5 as the default value recommended by the loop detector card manufacturer, but in our experience, much lower sensitivity settings were required to prevent false triggering, typically 2 or 3. Problems with the loops including failures of Type 222 detector cards at the evaluation test sites were common, and became a source of our frequent requests for assistance from district maintenance personnel (which diligently responded). But this suggests that similar problems were being encountered throughout the CAWS, with or without the immediate knowledge of the CAWS system operators, since partial failures or calibration drift can go unnoticed in the period average speed data reported by the traffic monitoring sites.

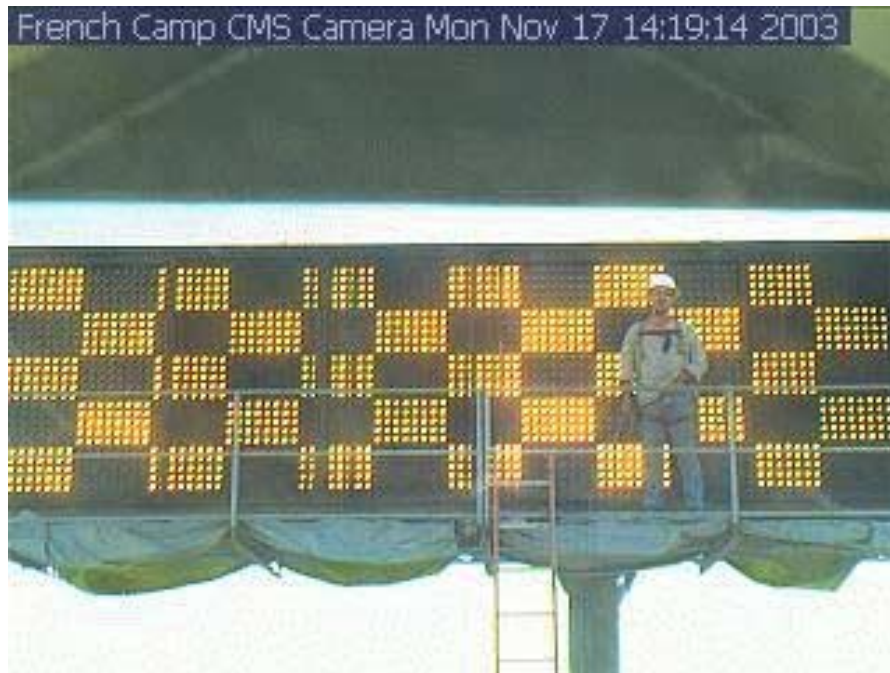
Base on our observations and interviews with district maintenance personnel, we were not aware of any significant problems with the CAWS CMSs during our period of evaluation. A persistent problem with occasionally “stuck-on” or burned-out bulbs was observed, which can be seen in the dusk (right) photo of Figure 3.2.4.1. This problem was eliminated following a major panel replacement in November 2003, just prior to the first full fog season considered in the driver behavior study, as captured by our CMS verification camera in Figure 3.2.4.2.

Figure 3.2.4.2. CMS 1 panel replacement, recorded by our CMS verification camera on Nov. 17, 2003.

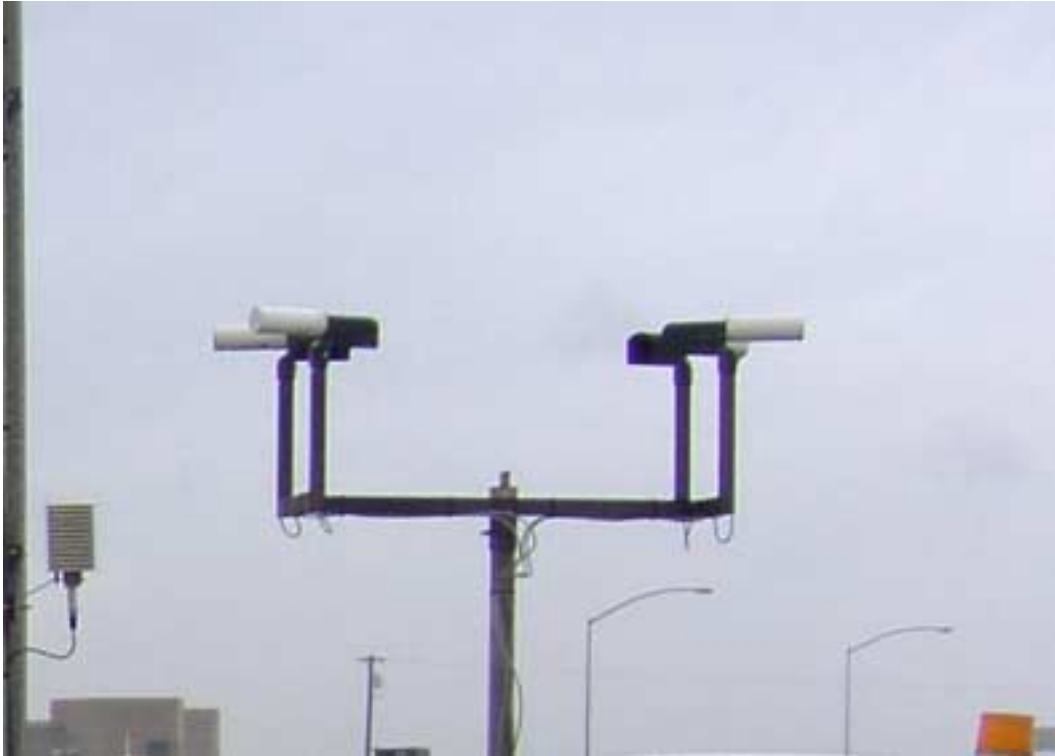
Figure 3.2.5.3. Qualimetrics Model Z004510 forward scatter visibility sensor (center) and Model 5140 temperature/humidity probe (left), installed at each remote weather station in the CAWS.

The visibility sensor required the most frequent service (once a month according to the manufacturer's manual), due to the need to periodically clean the windows on the two emitters and two detectors, seen in Figure 3.2.5.3. In addition, frequent recalibration was recommended, since the detector was prone to drift with time. Each of the emitters and detectors contained heaters to prevent condensation forming on the optics. According to the District maintenance staff, the most common failure items in the weather system were the heaters in the visibility sensors.

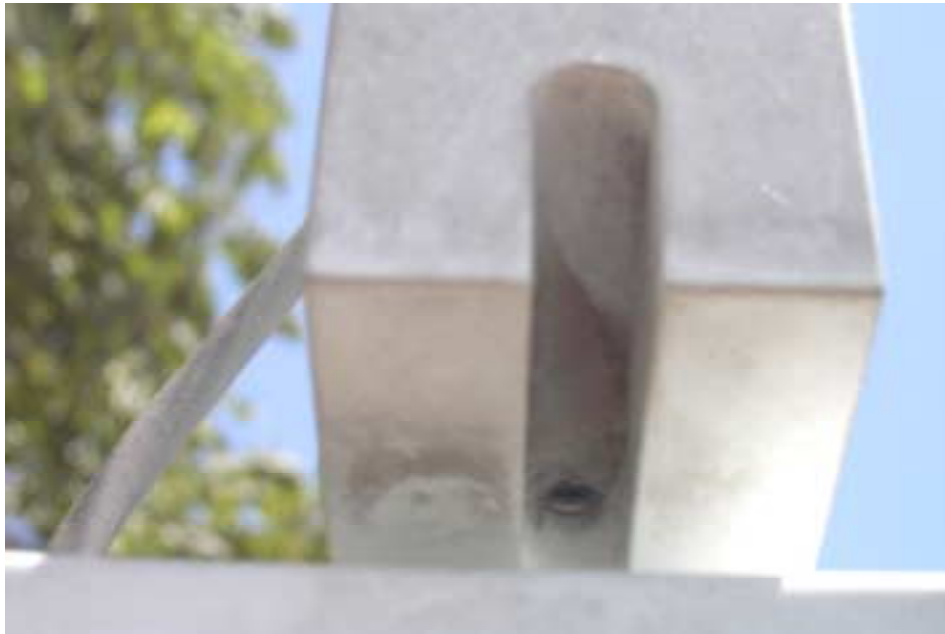
One infrequent but often unnoticed problem was the day/night sensor. We were aware of two failures, but a more common problem is shown in Figure 3.2.5.4. The aperture of the sensor was an ideal home for spiders, and dense webs or egg sacs were found in two sensors. Since the small photocell window was difficult to access, it was not a scheduled maintenance item, and the day/night sensor was not usually checked. If the day/night sensor is blocked, the QCMS system will still report visibility readings, but they are based on night calculations which can differ significantly from the correct daytime readings.

Figure 3.2.5.4. Day/night sensor blocked by spider egg sac.

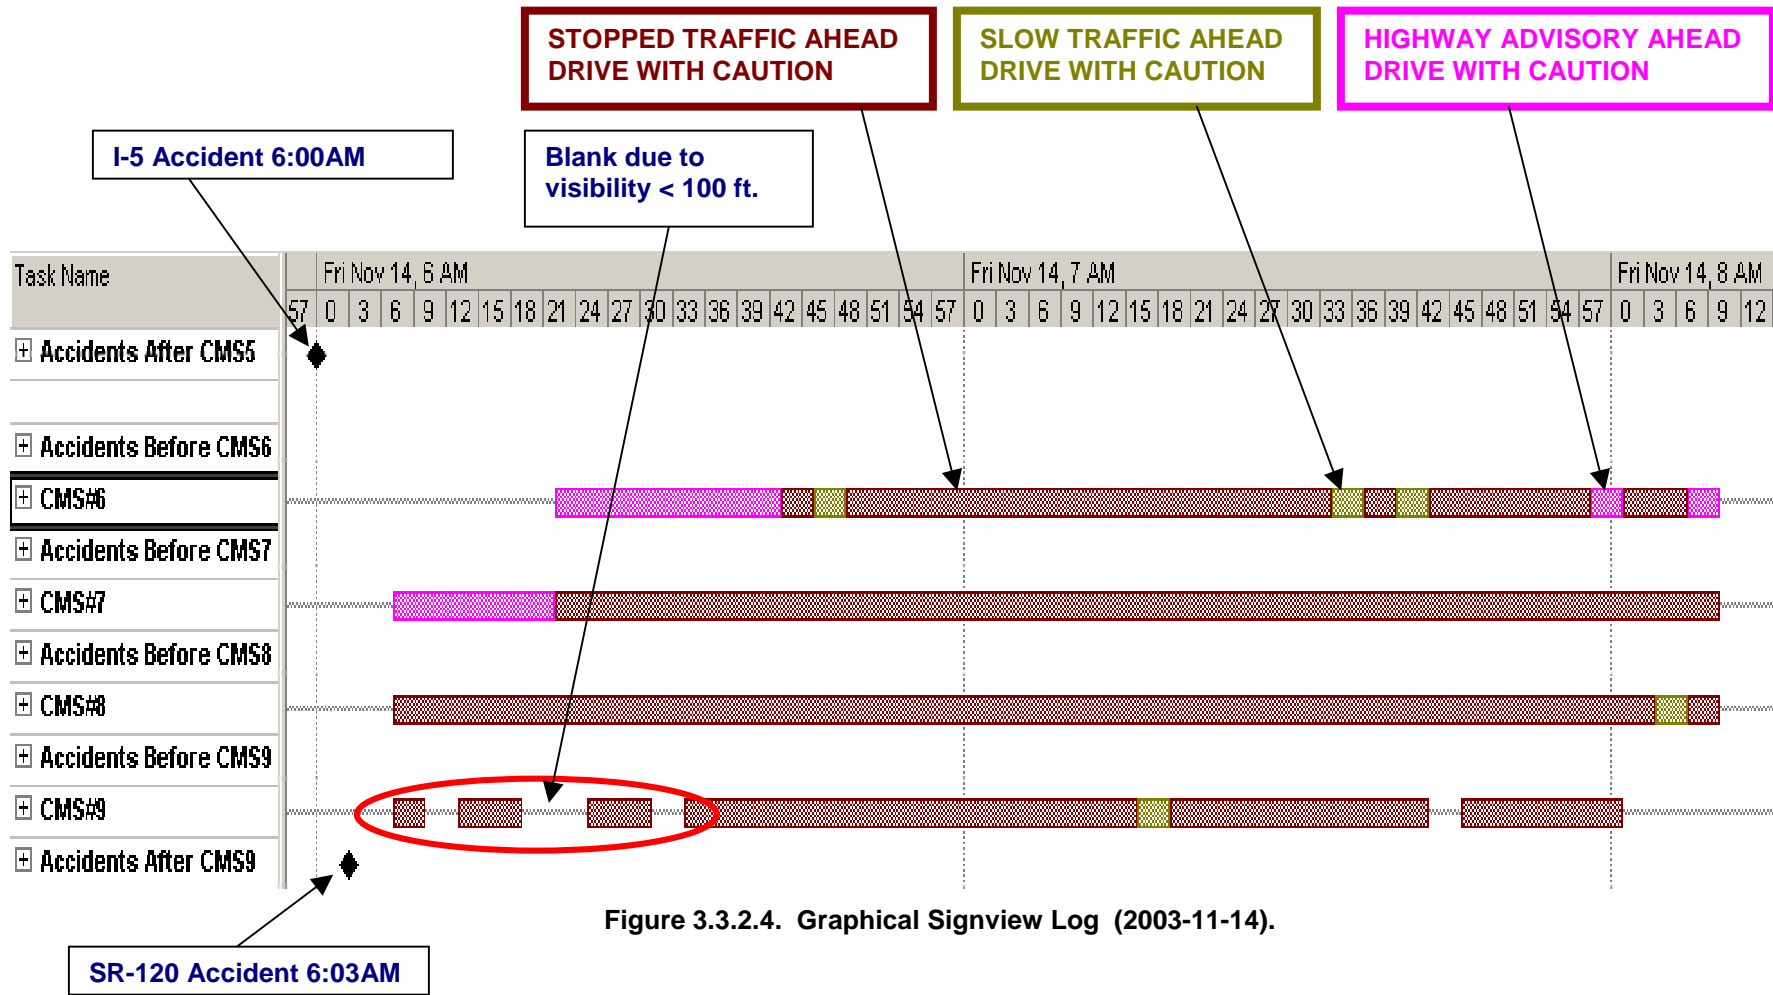
As shown in Figure 3.3.2.4, there are several breaks in the activation of CMS 9. The "STOPPED TRAFFIC AHEAD" message was issued by CMS 9 several times in succession with interruptions between each issue. This intermittency was attributed to erroneous speed data sent from 170 controller. As stated earlier, the TMS software inhibits activation from a loop site if it receives a speed report of 50 mph or greater in any lane at that site. The "STOPPED TRAFFIC" message was interrupted during this period because of intermittent erroneous readings of 117 mph in lane 1 at 6:31 am.

Also of note during this event was the lack of response from conditions in lanes 4 and 5 (slow lanes in merge section) at speed station 9E. This station appeared to be reporting data only from the three fastest lanes. This could have resulted from malfunctioning 222 loop detector cards, but is more likely due to the five-lane speed monitoring station 9E being configured the same as other sites which monitored only three lanes. The TMS algorithm does not distinguish between two, three or five lane sites. The zero values reported by the 170 controller in lanes 4 and 5 at station 9E could have caused a false activation of the CMS. However, it is unknown what volume (or count) data the 170 controller was reporting during this period. Since the TMS software invalidates speed data for a particular lane if the associated volume data is read as zero, it was possible that the speed data for Lanes 4 and 5 were completely ignored. Moreover, the 5-lane speed site 9E seldom causes a CMS activation since the fast lanes are through lanes, not merging with I-205, which rarely slow below 50 mph even when traffic in lanes 1 and 2 is stopped (frequently).

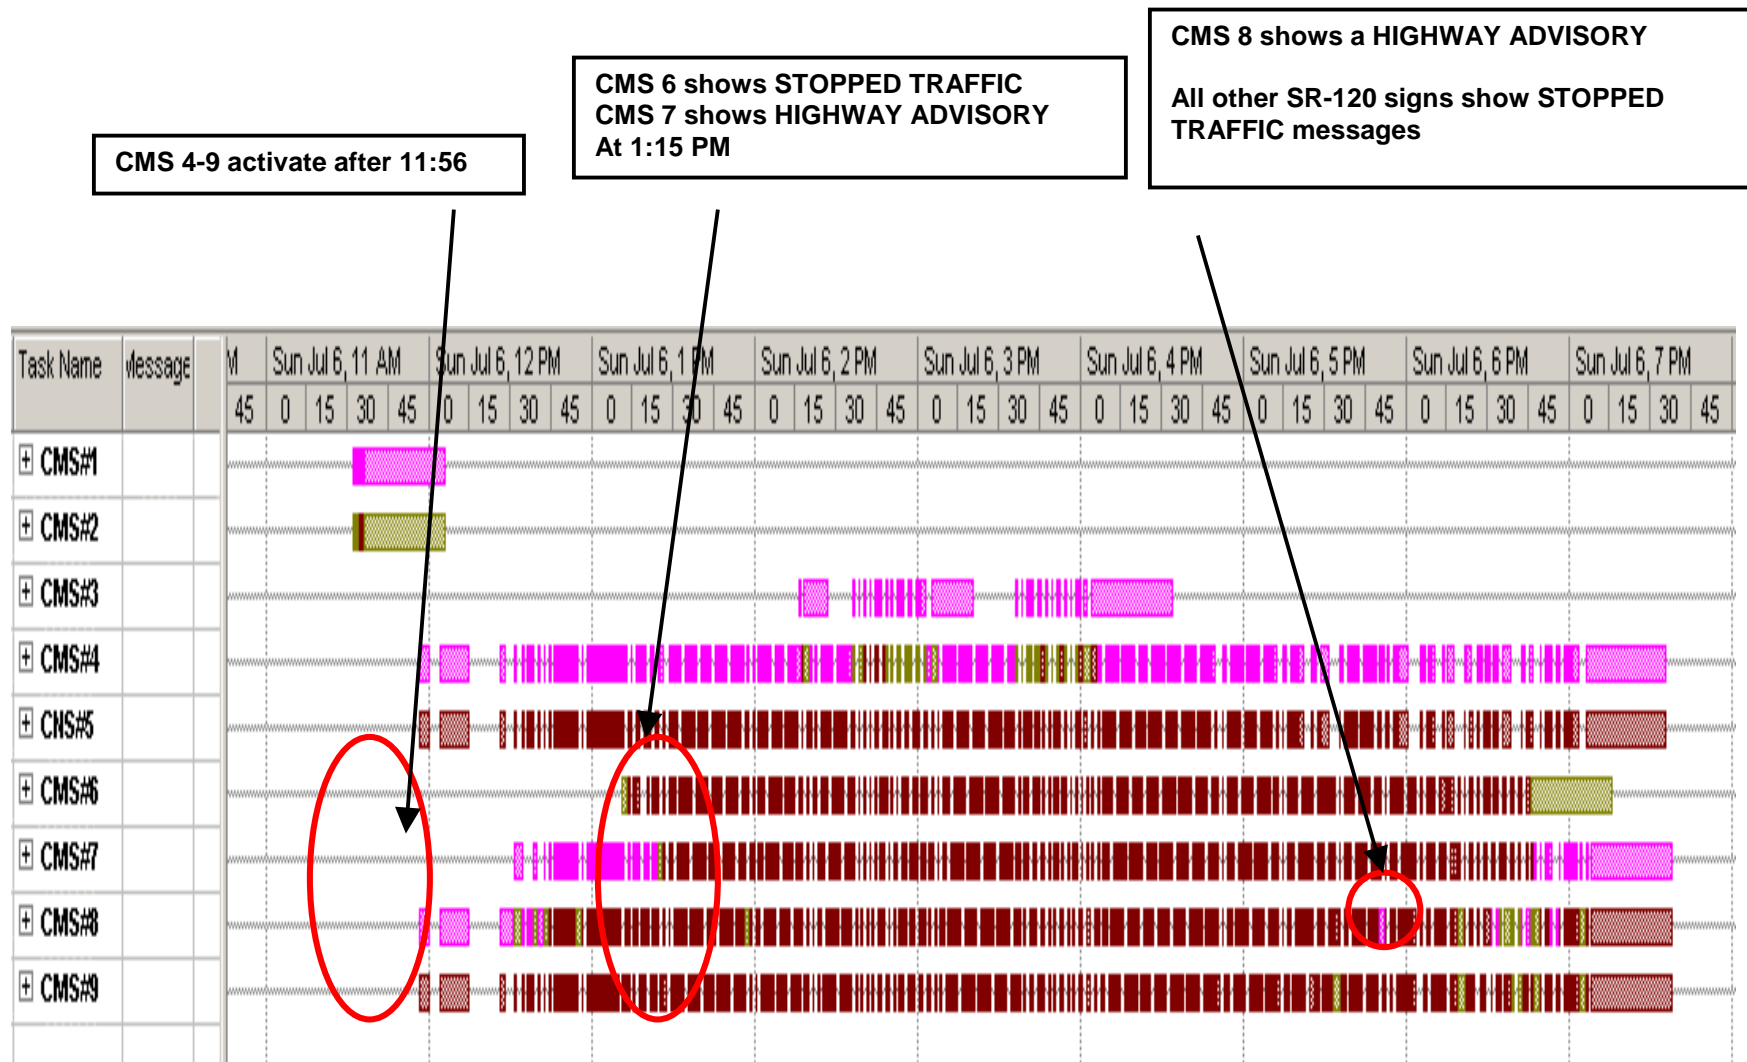
Figure 3.3.2.5. Graphical Signview Log File (1997-07-06).

The unusual response of the system in this and similar cases observed during the first year of CAWS operations motivated us to more closely investigate the actual system control strategy by examination of the Signview software source code². We discovered that the observed incorrect relationship between speed sites and CMS sites was due to the use of an incorrect version of the TMS mapping table, which

incorrectly associated speed monitoring sites with CMS's. This error was eventually found to be due to a change in the site numbering convention incorporated in the final system, but the retention of the old mapping table. The error was corrected during a system software update September 29, 1997, approximately eleven months after the start of CAWS operation. A derived complete diagram of the original version of the CMS-speed station mapping is shown and described later in Figure 3.8.1.2. Figure 3.3.2.6 is a subset of this diagram which provides a close-up of the activation path for CMS 6 and 1:15 pm. The speed log files for this event show that speed station 8E delivered data to Signview at 1:15 pm which triggered the stopped traffic message on CMS 6. The corresponding data from speed site 8E is shown in Figure 3.3.2.7.

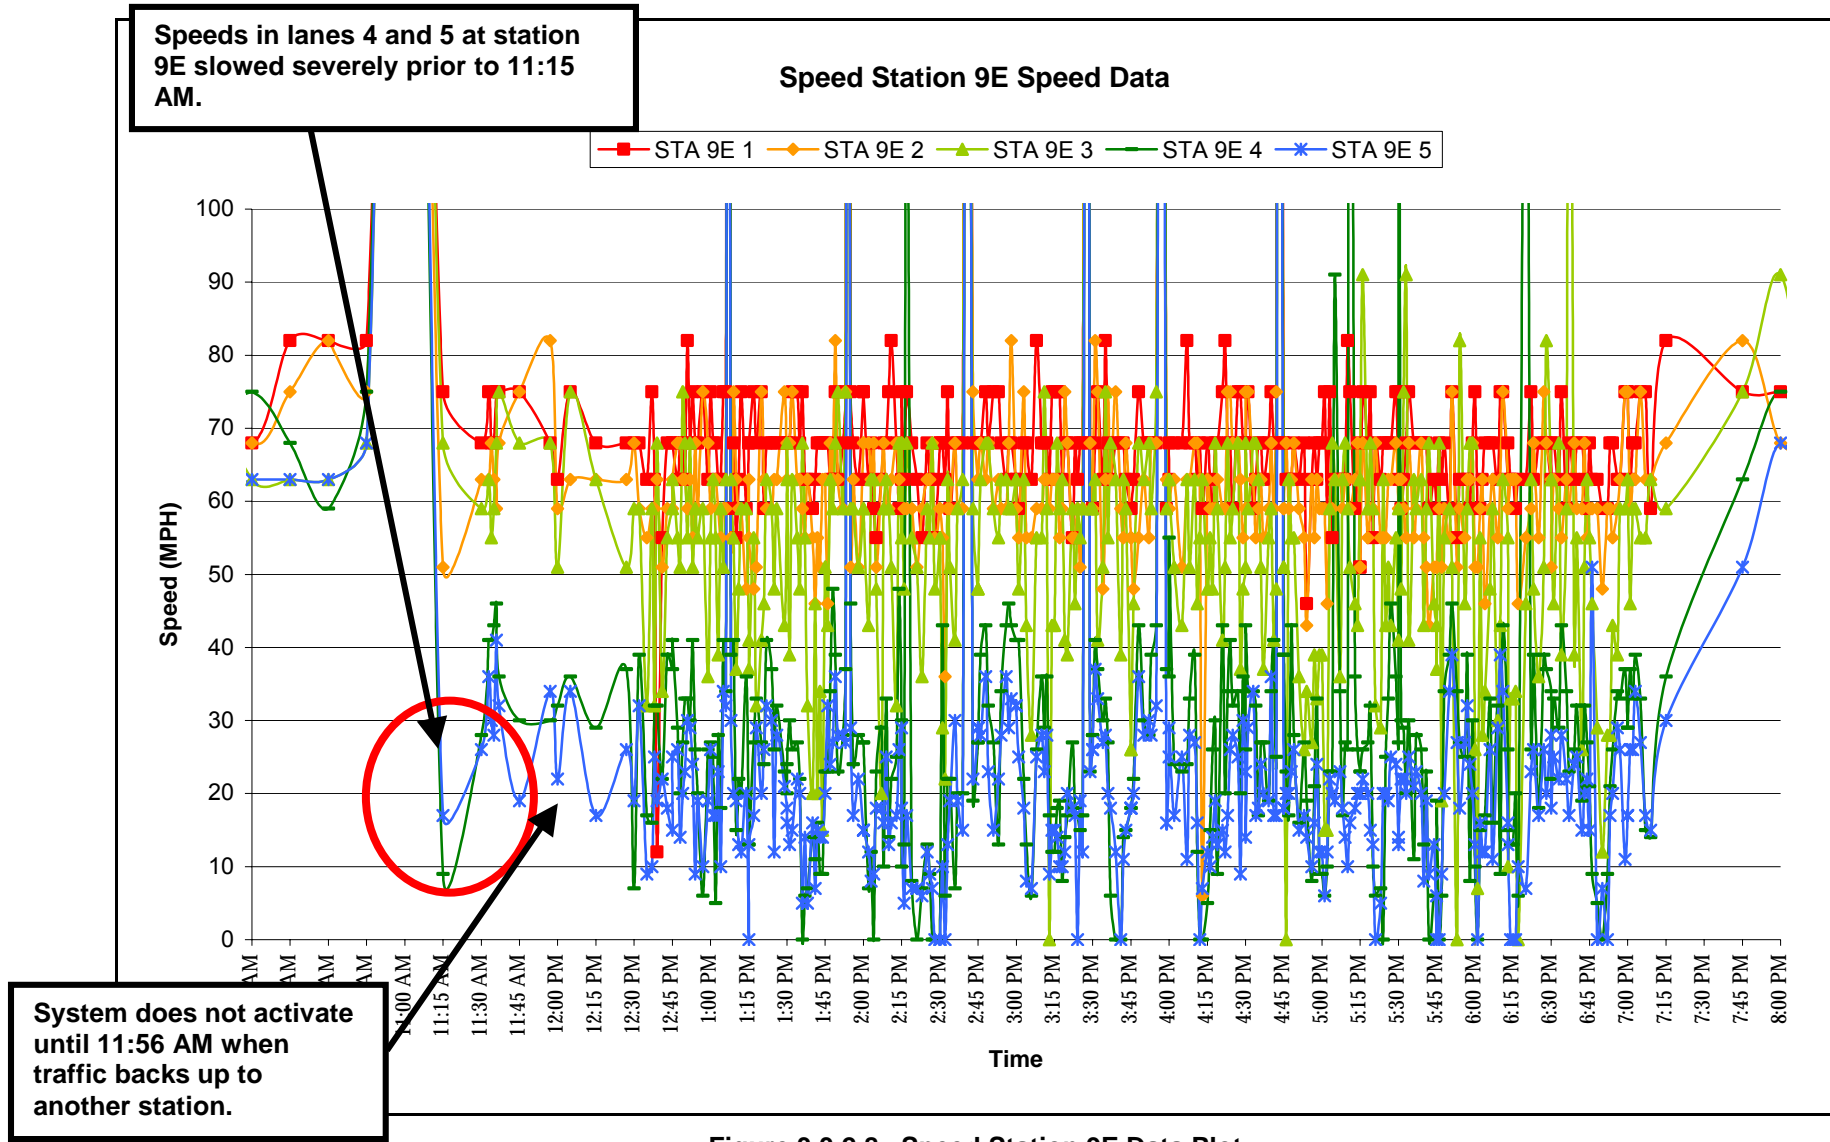
Figure 3.3.2.8. Speed Station 9E Data Plot.

On this same day, speed monitoring site 9E (the closest to the I-205 and I-5 split) showed signs of stopped traffic in lanes 4 and 5 prior to 11:15 am. This data is shown in Figure 3.3.2.8. But the system activated at 11:56 am, 41 minutes later. This delay occurred despite the stopped traffic condition in 4 and 5 at 5-lane Site 9E because lanes 1 and 2 were above 50 mph. Activation did not occur until traffic had backed up all the way to Y junction, and a slow traffic condition was detected by Site 8E.

Speed site 9E is the southern-most of four speed sites monitoring the 5-lane section after the I-5 and SR-120 merge area. Speed site 9E immediately precedes the westbound I-205 exit. If congestion occurs on I-205 and backs up into this transition section, speed site 9E is the first to detect it. Therefore, detection of slow or stopped traffic in the merge lanes at Site 9E is critical to providing advanced warning to drivers entering the I-5 / SR-120 merge zone.

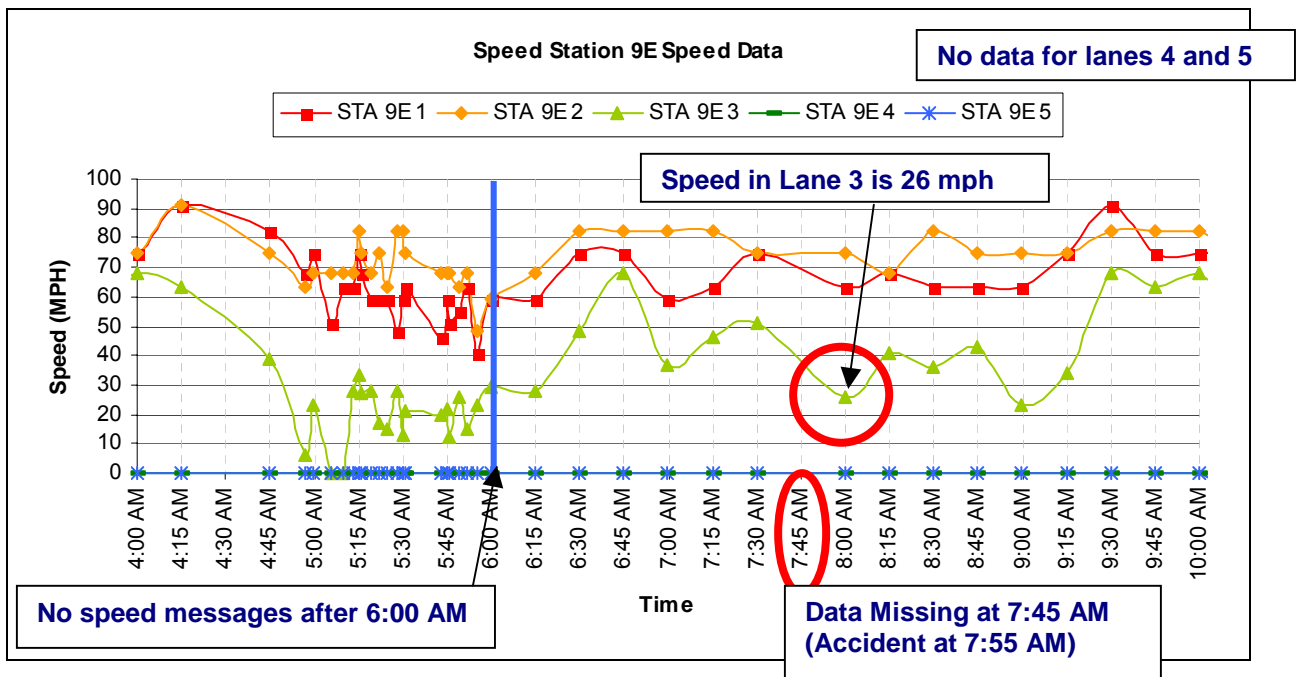
Figure 3.3.3.3. Speed Site 9E Speed Data.

Constant zeros were reported for the two slow lanes (Lanes 4 and 5) at the southernmost speed site 9E. Because volume information is not logged by the TMS software, there is no way to tell if ‘0’ meant 0 mph or no vehicles had been detected. The system failsafe assumption in the event of no data is zero volume, which inhibits the TMS from generating a speed alarm for these lanes, despite the obviously slow or stopped traffic condition in lanes 4 and 5 due to the accident at this location.

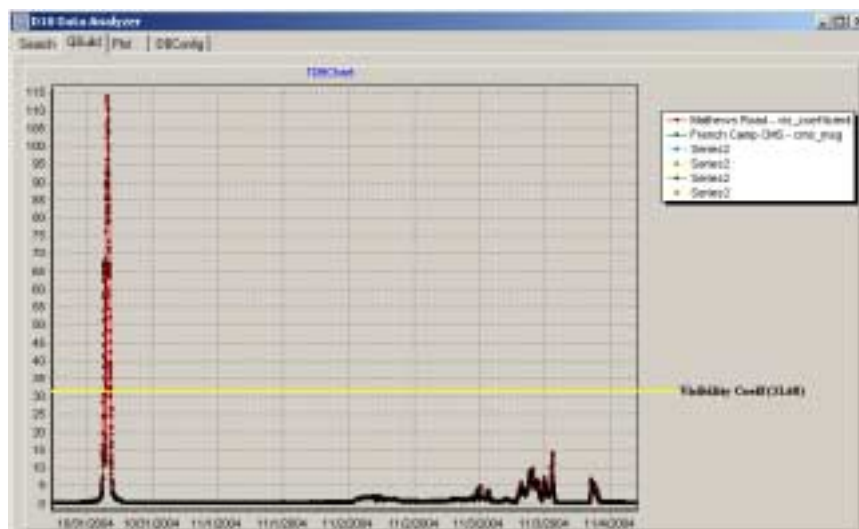
Figure 3.3.4.1. D10 Analyzer Screenshot

- All weather stations from 9-15-04 1:00 pm to 9-16-04 1:55 pm. Examining the CAWS-evaluation data indicates that there were no visibility activations generated by weather station 1 which leads to the assumption that there was a communication error during this time.
- Weather station 7 from 9-23-04 11:20 to 10-01-04 2:20 but communication problems started again on 10-01-04 8:40 to 11-03-04 14:45.
- All weather stations from 10-30-04 17:45 to 11-03-04 14:45. Examining the CAWS-evaluation data indicates that there was one visibility event missed. Figure 3.3.4.1 shows the D10 Analyzer output for this time period.

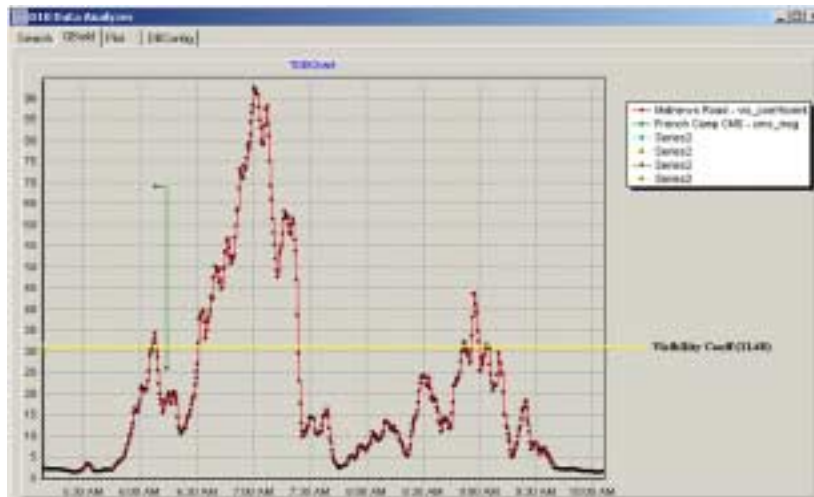
- Weather Station 7 from 11-07-04 6:35 to 11-21-04 21:35.
- All weather stations from 11-07-04 6:35 am to 11-10-04 10:05 am. Due to a communications failure, fog level flags of 2 and 3 were being sent to the Signview computer for weather stations 2, 3, 7 and 8. These flags were sent until 11-08-04 12:46:54 pm when a 'SYSTEM INIT' was sent which reset all flags to 0. Examining the CAWS-evaluation data indicates that two fog events were missed on 11-07-04. Figure 3.3.4.2 shows the D10 Analyzer output for this time period.

Figure 3.3.4.2. D10 Analyzer Screenshot, showing graphical depiction of fog over the course of an activation event, 11-07-04.

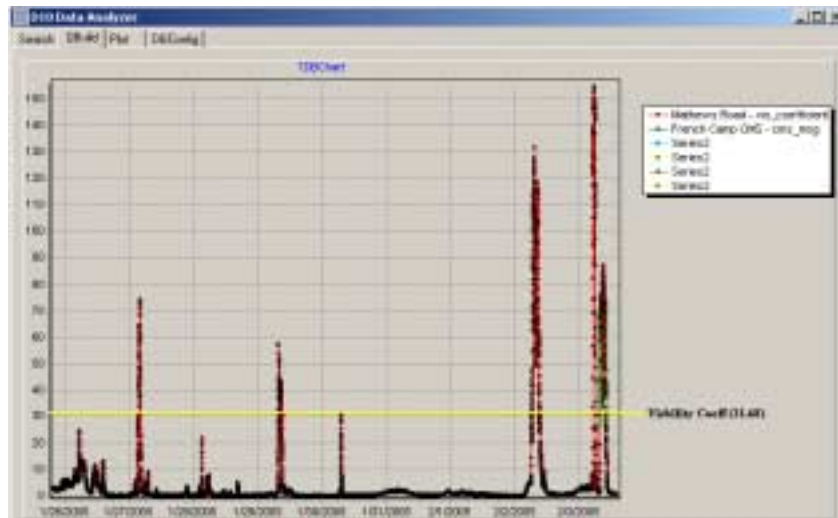
- Weather station 7 from 11-25-04 9:15 to 11-28-04 18:40.
- Weather station 7 from 12-01-04 9:30 to 2-02-05 10:05.
- All weather stations from 1-26-05 7:20 pm to 2-02-05 10:05 am. CAWS-evaluation data system data from this site (at Mathews Road) indicated that there should have been three visibility activations. Figure 3.3.4.3 shows a graphical depiction of the visibility levels for this time period. Dense fog periods are indicated by the peaks in the plot of the extinction coefficient from the visibility sensor at this station.

Figure 3.3.4.3. Visibility at WS 1, 9-day profile starting 1-26-05, from D10 Analyzer.

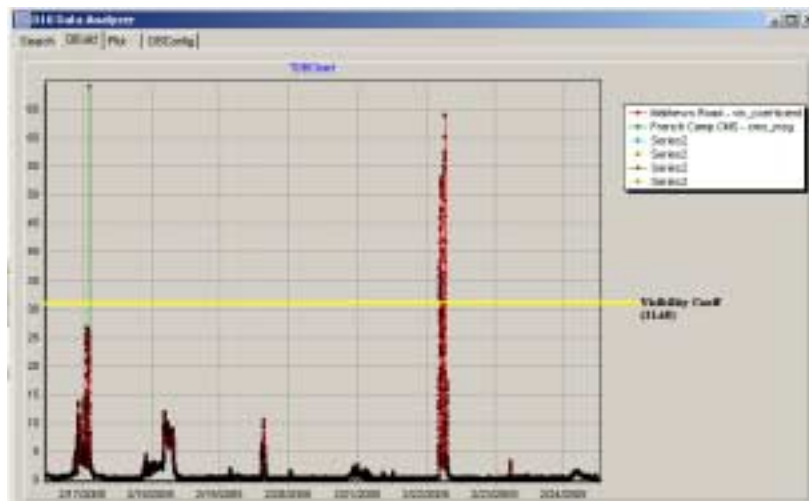
Figure 3.3.4.4. D10 Analyzer Screenshot, 2-17-05 through 2-24-05.

- Body Weather station 2 from 1-26-05 7:20 pm to later then 3-22-05 11:55 pm (Logs were only available through 3-22-05).
- All weather stations from 2-17-05 11:05 pm to 2-23-05 8:25 am. CAWS-evaluation system visibility data is shown in Figure 3.3.4.4 indicating the missed fog activation.

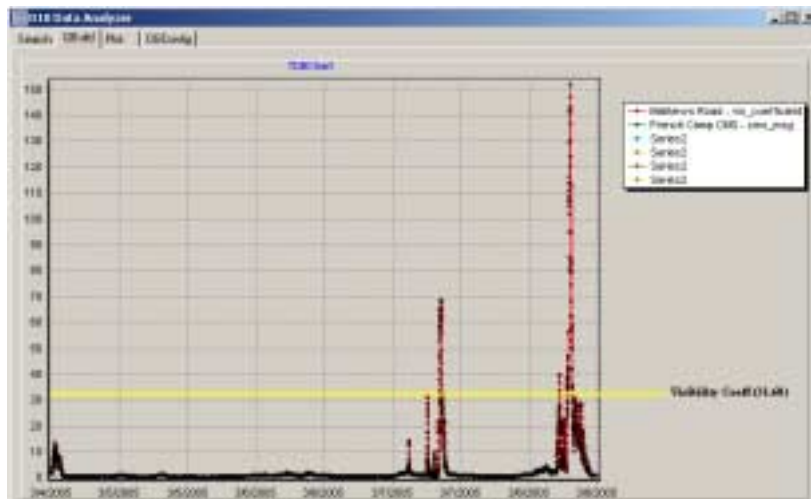
Figure 3.3.4.5. D10 Analyzer Screenshot.

- All weather stations from 3-05-05 4:05 am to 3-0-05 8:55 am. CAWS-evaluation data represented in Figure 3.3.4.5 shows two missed fog activations.
