INSTRUMENTATION AND EVALUATION OF DISTRICT 10 CALTRANS AUTOMATED WARNING SYSTEM (CAWS)

Technical and Operational Assessment

Prepared for the California Dept. of Transportation and California Office of Traffic Safety
by Loragen Corporation, San Luis Obispo, California

Document No. L-D10-FR-03

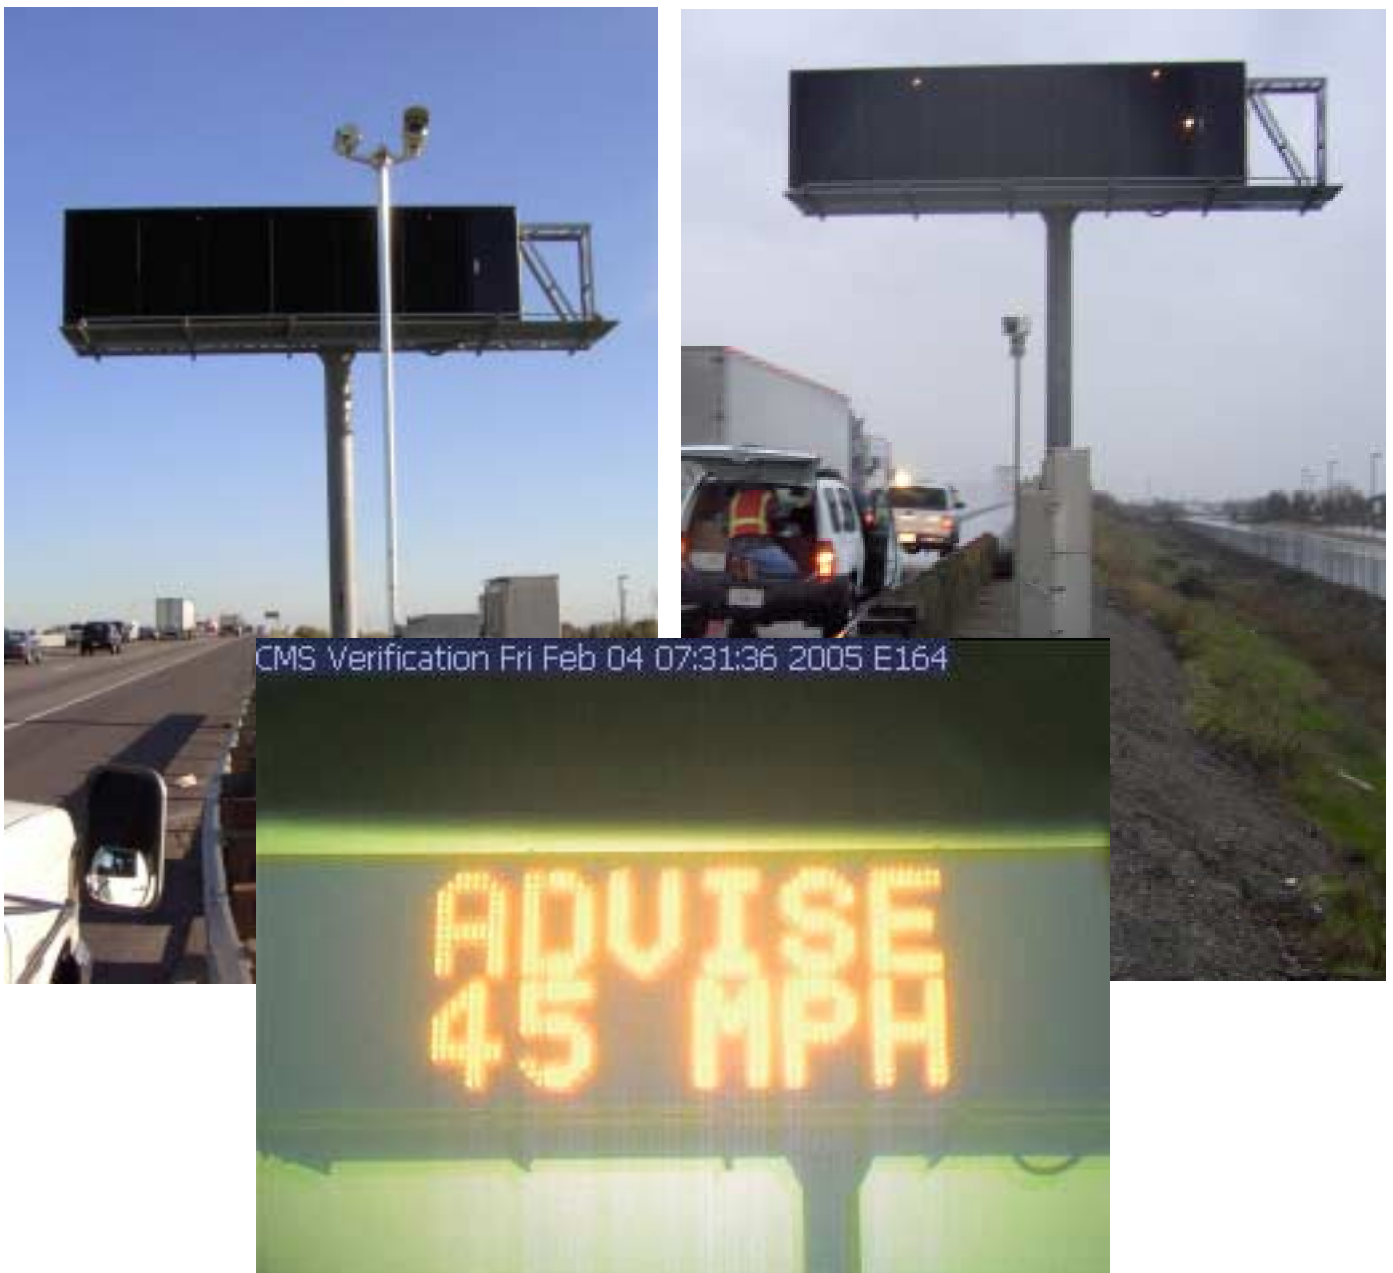
Figure 3.2.4.1. CMS 1, located near County Hospital Road (day on left, ADVISE 45 MPH Message in middle, dusk on right).

Base on our observations and interviews with district maintenance personnel, we were not aware of any significant problems with the CAWS CMSs during our period of evaluation. A persistent problem with occasionally “stuck-on” or burned-out bulbs was observed, which can be seen in the dusk (right) photo of Figure 3.2.4.1. This problem was eliminated following a major panel replacement in November 2003, just prior to the first full fog season considered in the driver behavior study, as captured by our CMS verification camera in Figure 3.2.4.2.

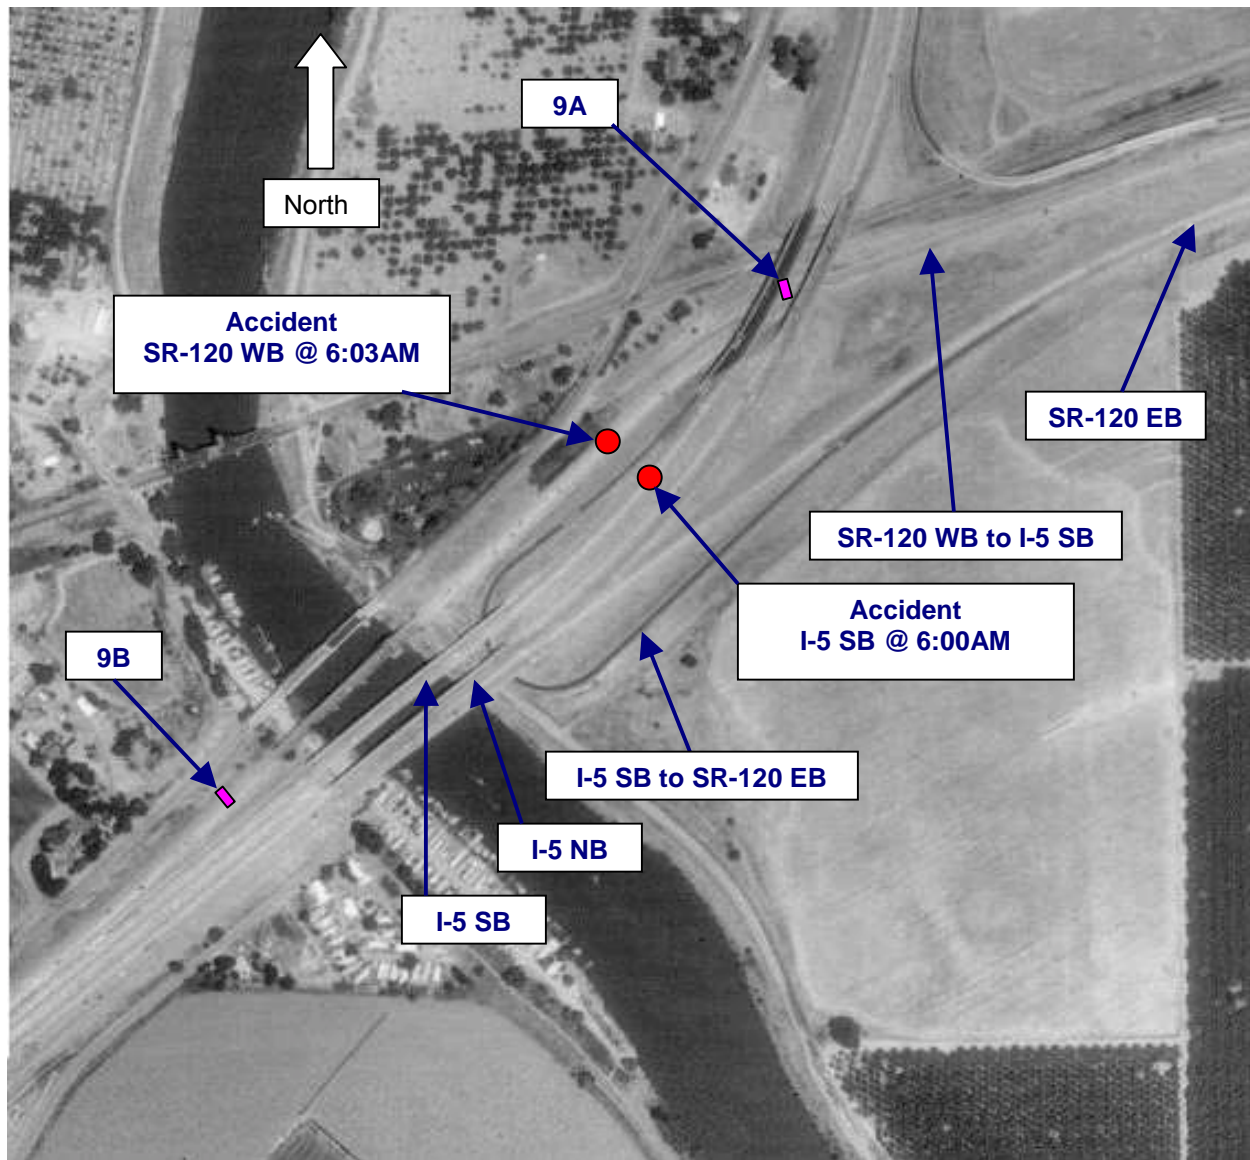
Figure 3.3.2.1. Accident Locations (2004-11-14).

A single-vehicle accident occurred on I-5 southbound at 6:00 am, approximately halfway between the San Joaquin River Bridge and the SR-120 underpass. The weather was clear, roadway conditions normal, and illumination was night/dawn with streetlights. The vehicle rolled over after hitting a metal light pole. One person was injured in this accident. The responding CHP officer noted that the primary cause of this accident was an unsafe turn by the vehicle.

Shortly afterward, at 6:03 am, there was an accident on SR-120 westbound in the same area. The same CHP officer responded to this accident and reported that an object in the road caused this incident. The object was most likely debris from the previous accident on I-5. The first vehicle hit an object and proceeded to contact the front right corner of a second vehicle, which had previously stopped. Figure 3.3.2.1¹ illustrates the approximate location of the two accidents. The pink rectangles indicate the approximate locations of speed monitoring stations 9A and 9B on SR-120 westbound. The milepost indicated on the CHP report for the first accident was “0.1 miles north of 5 SJ R14.607 or 110 feet south of W/B SR120.” The CHP officer noted that the vehicle needed to be towed away. It is possible that congestion occurred as a result of the overturned vehicle blocking the roadway.

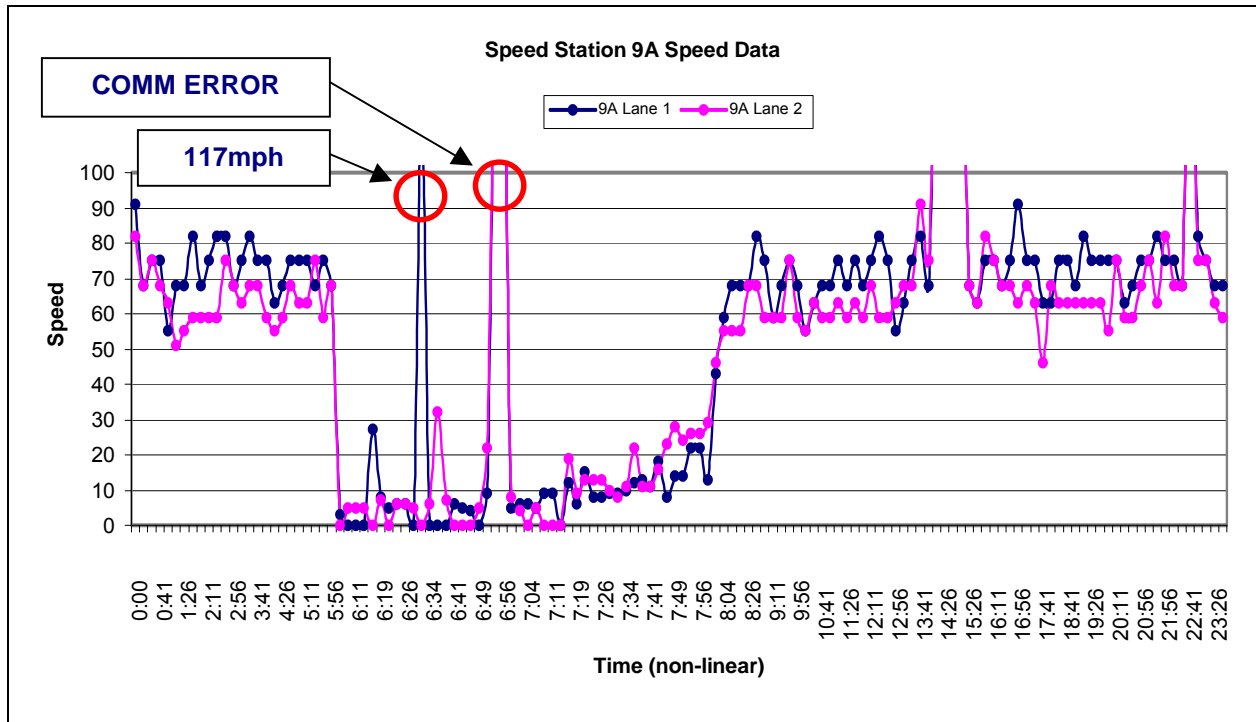
Figure 3.3.2.2. Speed Site 9A.

The exact location of the light pole referred to in the first accident report is unknown although the vehicle may have lost control around the I-5 bend. The traffic data from the TMS (speed monitoring) computer in the D-10 Traffic Management Center (TMC) showed that there were no significant speed disturbances before or after the 'Y' section on I-5 during this time. However, SR-120 traffic slowed down abruptly at speed station 9A. Only a minor decrease in speed was detected at speed site 9B which could be attributed to traffic regaining speed after passing the second accident. The speed data for sites 9A and 9B are shown in Figure 3.3.2.2 and Figure 3.3.2.3, respectively.

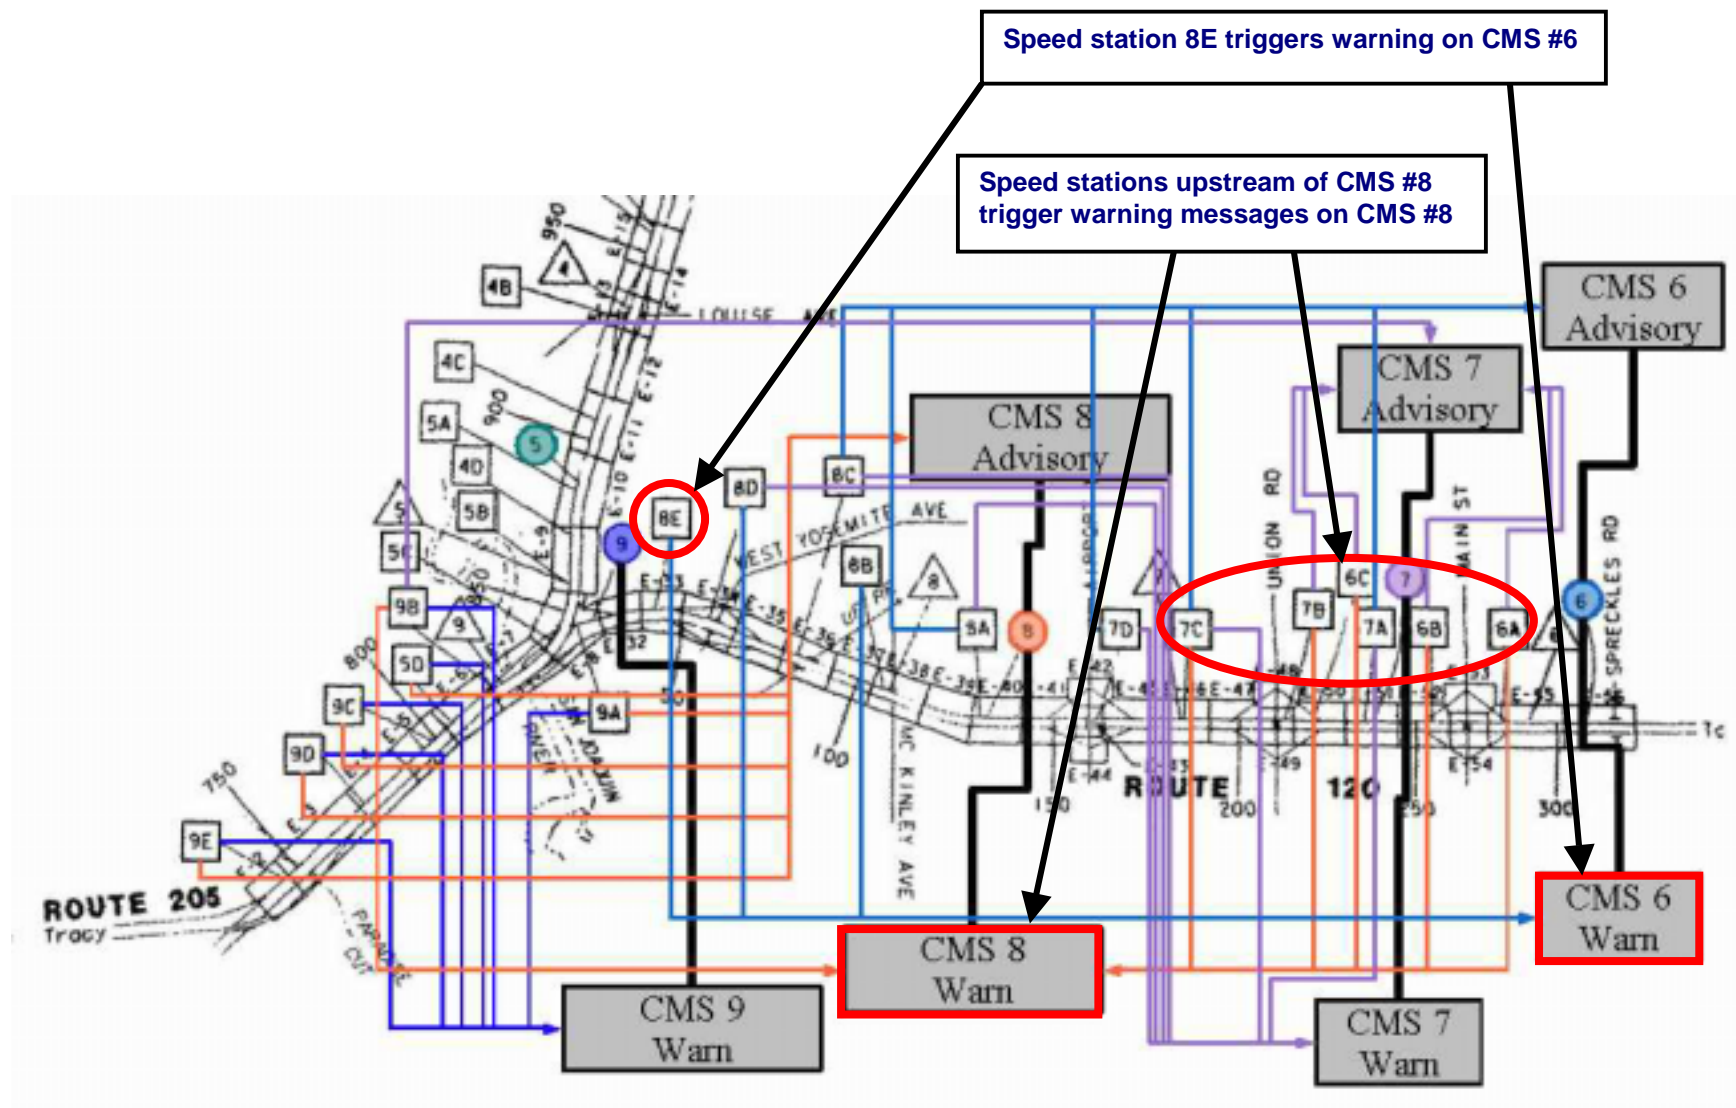
Figure 3.3.2.6. SR-120 Speed Site – CMS Mapping.

The unusual response of the system in this and similar cases observed during the first year of CAWS operations motivated us to more closely investigate the actual system control strategy by examination of the Signview software source code². We discovered that the observed incorrect relationship between speed sites and CMS sites was due to the use of an incorrect version of the TMS mapping table, which

incorrectly associated speed monitoring sites with CMS's. This error was eventually found to be due to a change in the site numbering convention incorporated in the final system, but the retention of the old mapping table. The error was corrected during a system software update September 29, 1997, approximately eleven months after the start of CAWS operation. A derived complete diagram of the original version of the CMS-speed station mapping is shown and described later in Figure 3.8.1.2. Figure 3.3.2.6 is a subset of this diagram which provides a close-up of the activation path for CMS 6 and 1:15 pm. The speed log files for this event show that speed station 8E delivered data to Signview at 1:15 pm which triggered the stopped traffic message on CMS 6. The corresponding data from speed site 8E is shown in Figure 3.3.2.7.

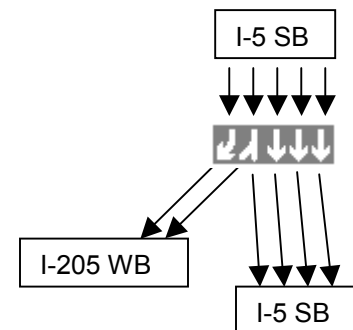
On this same day, speed monitoring site 9E (the closest to the I-205 and I-5 split) showed signs of stopped traffic in lanes 4 and 5 prior to 11:15 am. This data is shown in Figure 3.3.2.8. But the system activated at 11:56 am, 41 minutes later. This delay occurred despite the stopped traffic condition in 4 and 5 at 5-lane Site 9E because lanes 1 and 2 were above 50 mph. Activation did not occur until traffic had backed up all the way to Y junction, and a slow traffic condition was detected by Site 8E.

Speed site 9E is the southern-most of four speed sites monitoring the 5-lane section after the I-5 and SR-120 merge area. Speed site 9E immediately precedes the westbound I-205 exit. If congestion occurs on I-205 and backs up into this transition section, speed site 9E is the first to detect it. Therefore, detection of slow or stopped traffic in the merge lanes at Site 9E is critical to providing advanced warning to drivers entering the I-5 / SR-120 merge zone.

The 5-lane merge zone at the convergence of I-5 and SR-120 (known as the Mossdale Y) is known from the Collision Data Analysis volume of this report to be an area of relatively higher accident rates, and was one of the original motivations for the construction of the CAWS. It appears from the TMS log data that the “inhibit if any lanes greater than 50 mph” strategy that may have been appropriate in the two or three lanes sections of the CAWS area, was inappropriate in this case, since the actual merge lanes (4 and 5) are routinely backed up due to congestion on SR-205, but are beyond the sight distance of traffic approaching from either SR-120 or I-5. Lanes 1-3 are through lanes for I-5 which typically flow at speeds greater than 70 mph. In this case, the 50 mph inhibit strategy resulted in the system’s inability to activate at the ‘Y’ due to congestion occurring only in the merge lanes.

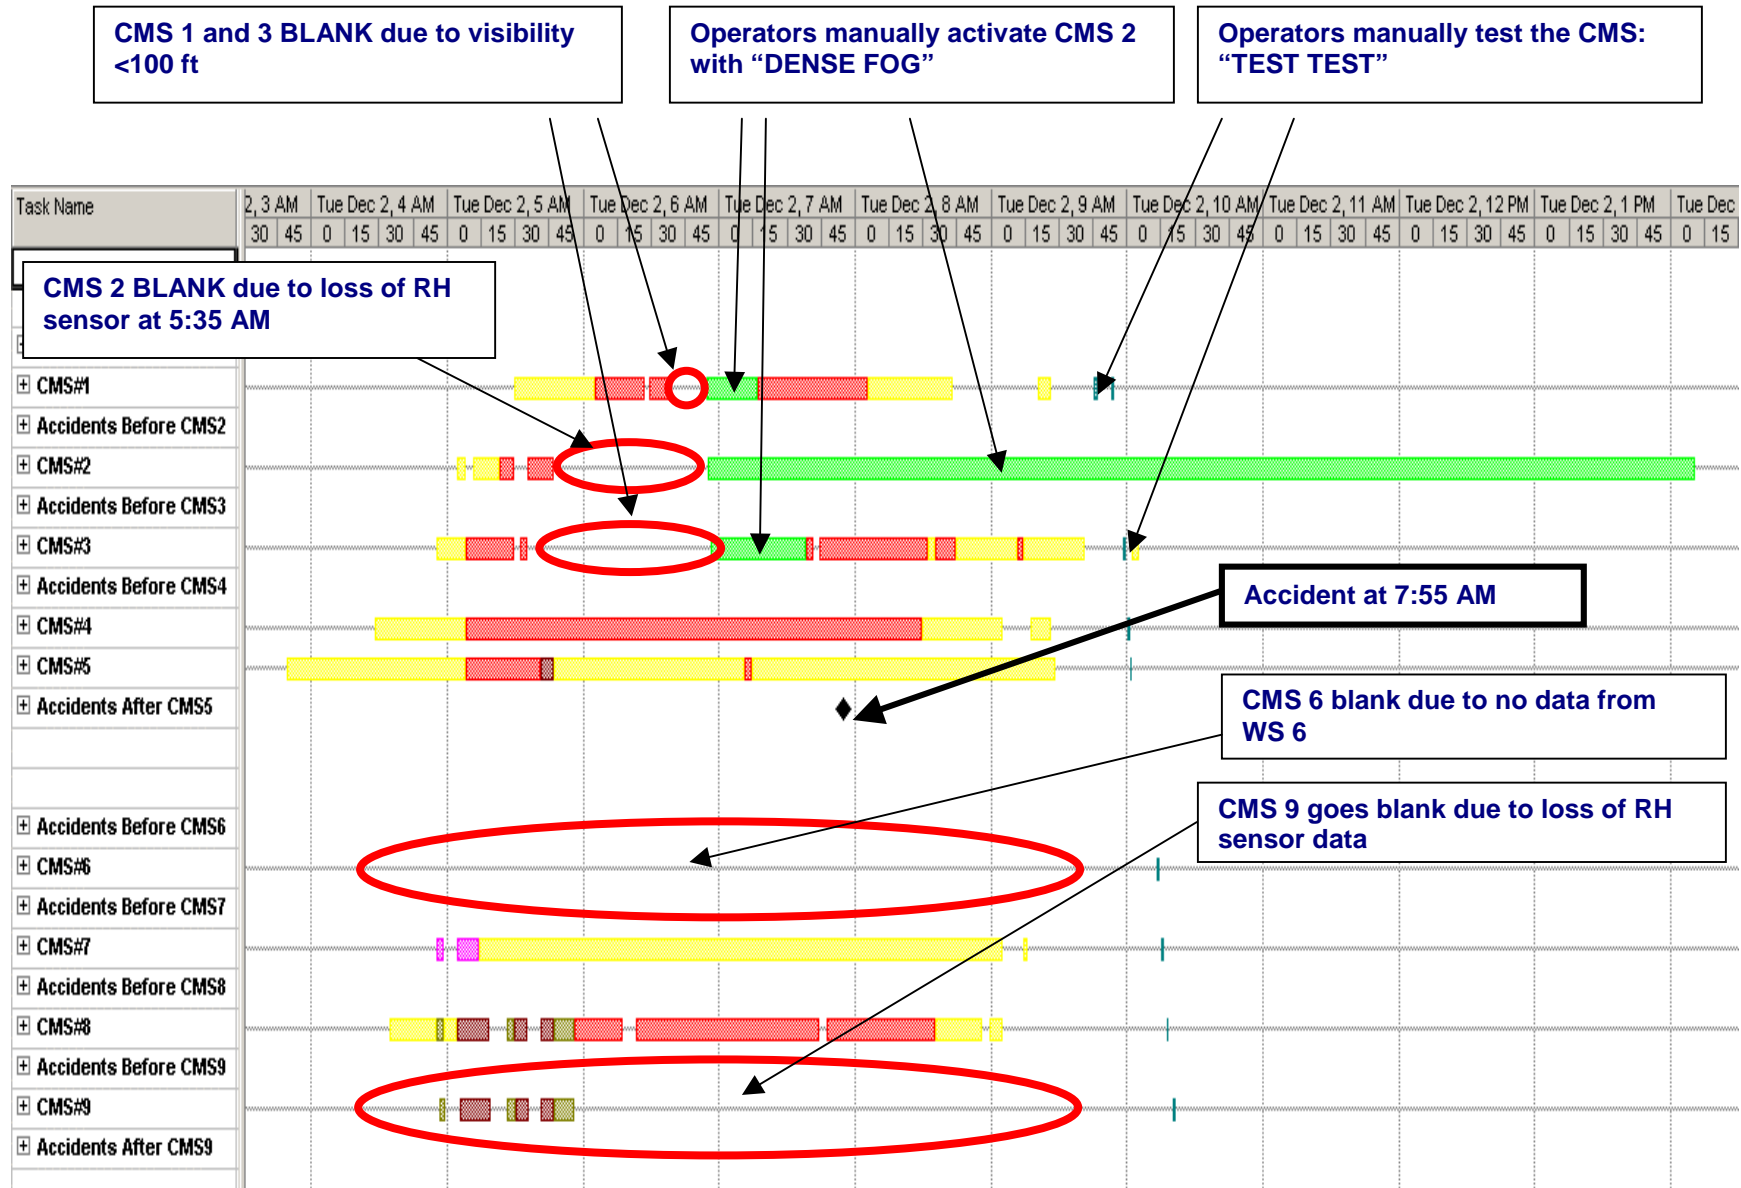
Figure 3.3.3.1. Graphical Signview Log File (2003-12-02).

A similar sensor failure occurred concurrently at Weather Station 2. Weather station 2 was operating correctly up until 5:35 am after which the RH sensor reported a negative wet bulb temperature. This changed the alarm type reported by the QCMS computer from fog to non-fog visibility during this period of dense fog. The sequence of communications strings sent by the QCMS computer to the Signview computer appear below, showing the alarm type change from fog (02) to non-fog (06) at 5:35:41 am.

During the middle of the event (approximately 6:55 am), the system operators apparently realized that CMS 1, 2, and 3 were had gone blank, unaware of that the reason was a software error. The system operators decided to take preemptive action and manually activated those CMSs with a “DENSE FOG” warning in an attempt to override the system. Starting at 9:45am, the system operators tested all the CMS connected to the system, presumably to test if Signview’s inability to display messages was possibly due to communication problems. The system operators found that their test messages displayed correctly. However, a communications problem apparently occurred with CMS 2 at approximately 9:30 that made it impossible to manually remove the “DENSE FOG” message until the problem was resolved after 2:00 pm. Visibility was clear after approximately 10:15 am.

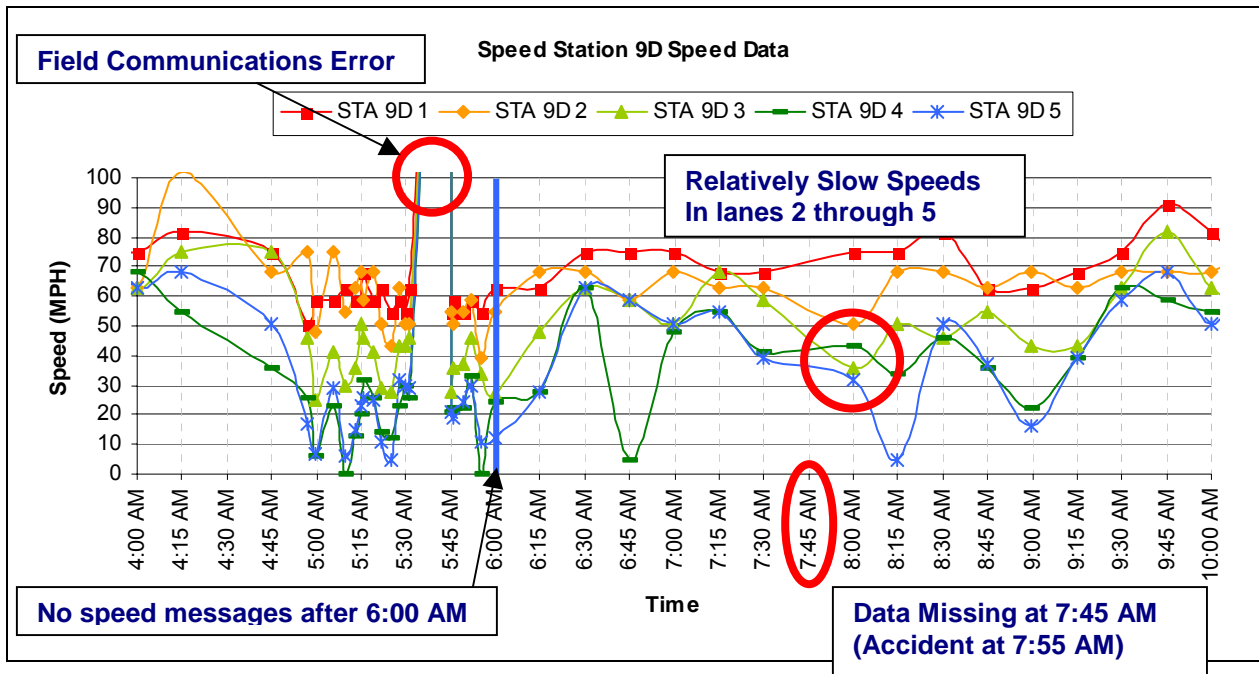
Figure 3.3.3.2. Speed Site 9D Speed Data.

Following the accident, the system did not activate for speed despite the slow or stopped traffic in lanes 4 and 5 at speed stations 9D and 9E, since speeds in the I-5 through lanes (1-3) did not all drop below 50 mph. In fact, the speed log file shows that no speed conditions were detected after 6:00am. At this time, the log file resumed the 15-minute logging interval. Unfortunately, the 7:45am reading was absent from the speed log file, potentially due to a full-system communications interruption. That entry would have immediately preceded the 7:55 am accident. Figure 3.3.3.2 and Figure 3.3.3.3 indicate that the system detected slow speeds before the accident occurred.

Constant zeros were reported for the two slow lanes (Lanes 4 and 5) at the southernmost speed site 9E. Because volume information is not logged by the TMS software, there is no way to tell if ‘0’ meant 0 mph or no vehicles had been detected. The system failsafe assumption in the event of no data is zero volume, which inhibits the TMS from generating a speed alarm for these lanes, despite the obviously slow or stopped traffic condition in lanes 4 and 5 due to the accident at this location.

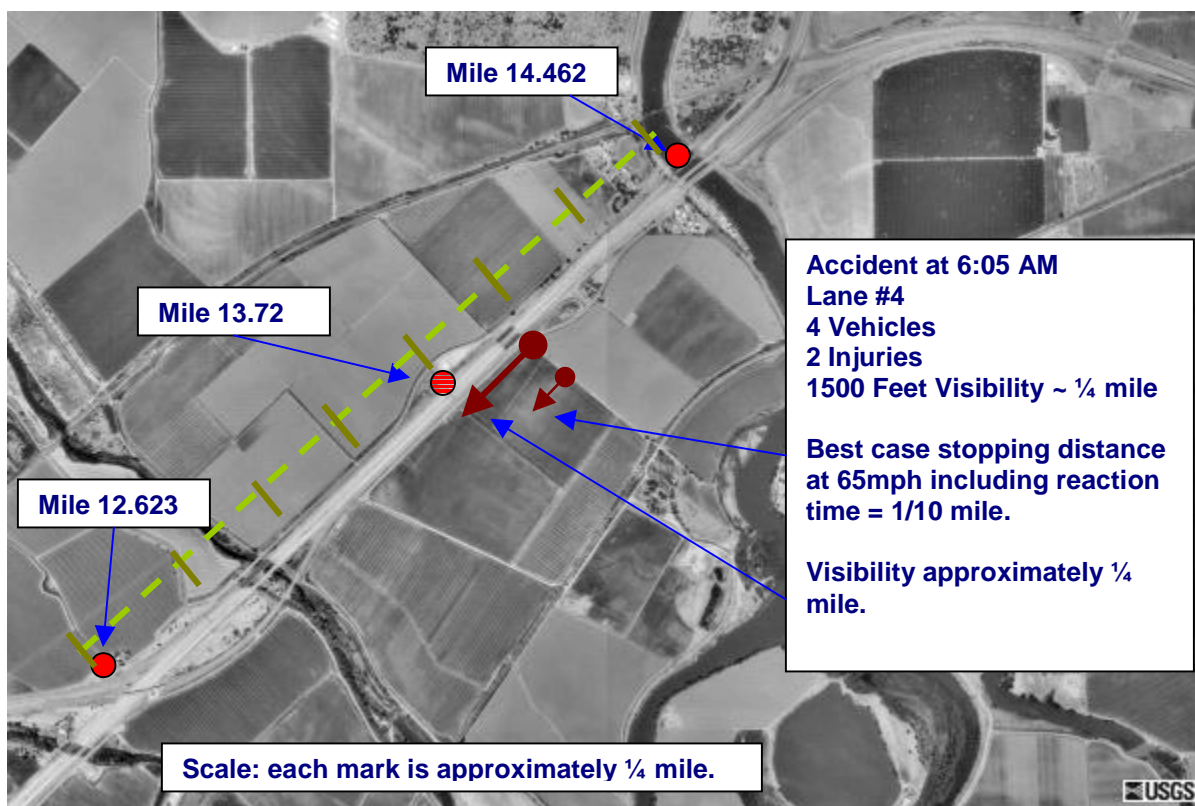
Figure 3.3.3.5. Accident Location (2004-01-12).

Weather Station 9, the closest to the accident, reported visibility as 324 meters (1063 feet); the other CMSs showed similar readings. The worst visibility was reported at Weather Station 1 (Mathew’s Road) and was 890 feet. The QCMS communications log entries for all Weather Stations at 6:00 am are shown below. The logging interval for the QCMS was 5 minutes. The M M M fields in the entry for Weather Station 9 indicate “Missing Data” at the reporting time.

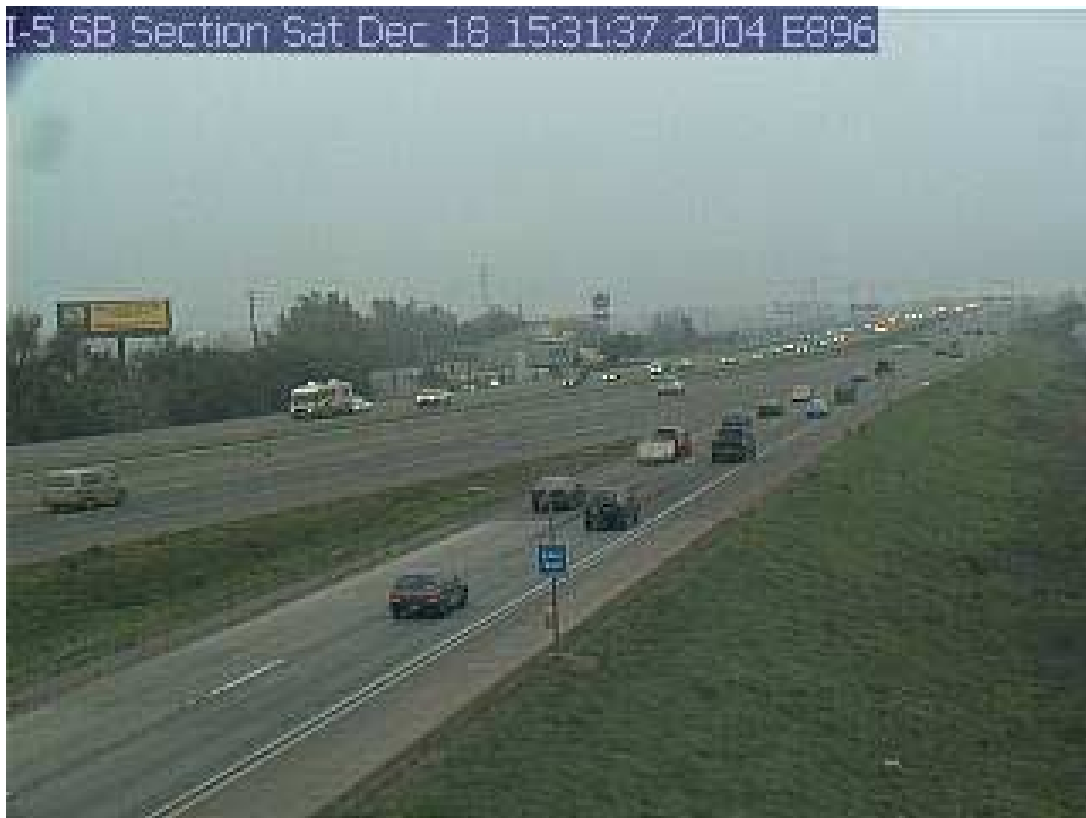
Figure 3.5.1.1. WB SR-120 Merge to SB I-5 at Mossdale Y.

This approach seems reasonable for sites at which all lanes are through lanes, or lanes subject to queues are treated separately. However, as noted previously, this approach is flawed in the 5-lane merge section of the Mossdale Y, a known area of high accident rates. Figure 3.5.1.1 shows an image of the WB SR-120 merge zone I-5 SB taken by a network camera we placed at the weather station 9 near the Mossdale Y to better understand the concentration of accidents in this area. Lanes 4 and 5 are the rightmost lanes in the image. Lanes 4 and 5 provide a merge zone both for traffic transitioning from WB SR-120 onto SB I-5, and for traffic converging from I-5 and SR-120 onto WB SR-205. These lanes are frequently subject to slow or stopped traffic, while lanes 1, 2 and 3 are through lanes on SB I-5. The lane speed gradient is particularly severe at the end of this 0.5-mile merge zone, where lanes 4 and 5 transition onto SR-205. SR-205 is subject to recurrent congestion during commute hours, which backs up traffic into the merge zone. Figure 3.5.1.2 shows a diagram of a typical lane speed gradient at the SR-205 connector.

Speed monitoring sites 9B, C, D and E are located in this critical merge zone and are intended to activate the CMSs on I-5 and SR-120 just prior to the Y. The above 50 mph speeds in lanes 1, 2 or 3 inhibit these sites from reporting alarm levels other than 0 due to this logic. Once traffic backs up all the way onto the SR-120 transition road before the merge, speed monitoring sites 5A and B detect the slowed or stopped traffic and can activate CMS 9 to warn traffic entering from 120 (only). However, this is too late: traffic entering the Y can see no warning of slow or stopped traffic as little as 0.2 miles ahead. This is particularly important for traffic entering from 120 since the transition road enters the Y through a left turn under a railroad trestle with limited sight distance. The proximity of the Mossdale landing and waterway also makes this location particularly prone to fog, which further reduces sight distance, especially during morning commute hours during the fog season. While the road geometry and natural environmental conditions are primarily responsible for the elevated accident risk at this location, correction of the control strategy for this special situation could result in a more effective warning, and encourage greater driver confidence in the CAWS system.

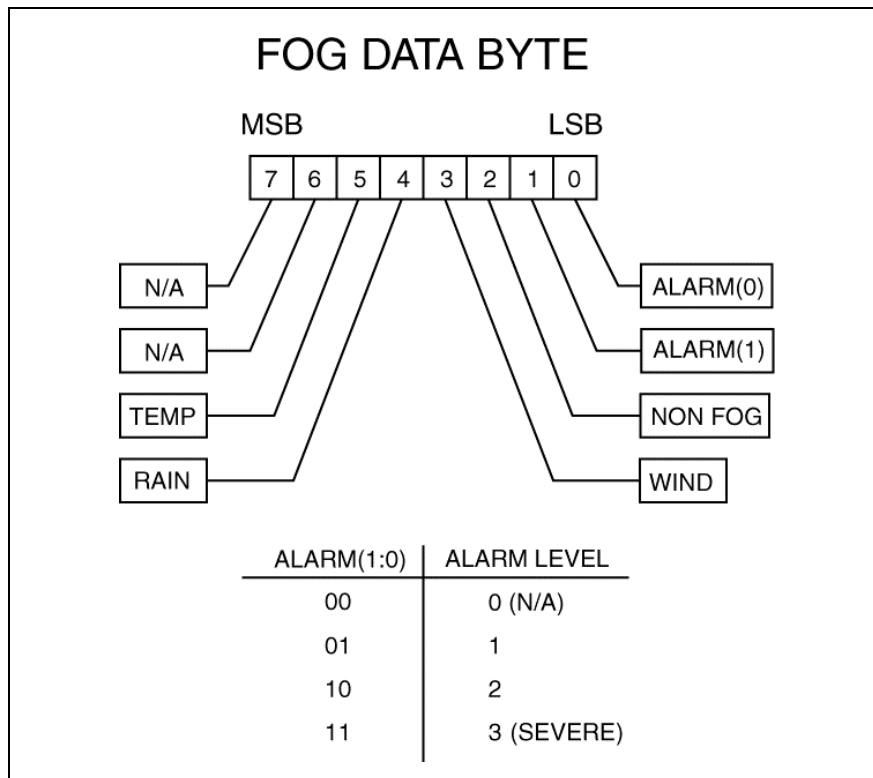
Figure 3.5.2.2. Fog level alarm byte bit definitions.

In data transmitted to Signview, the QCMS computer sends two bytes of information per weather station: the first byte contains the weather station number and the second byte contains an alarm flag status. The alarm flag byte is referred to as the “FOG DAT” or “WS FLAGS” byte inside Signview. The mapping of alarm codes to byte values is shown in Figure 3.5.2.1. The format of the alarm flag byte is further explained in shown in Figure 3.5.2.2. Only the two least significant bits are read by Signview for messages activation purposes.

computer. However, the mapping between the alarm level and the appropriate fog warning message is established by Signview. A configuration file allows the assignment of messages to alarm levels one and two. Alarm level three is not handled by Signview. In Signview source code module SV12A.c starting at line 675, a hard-coded blank message is assigned for visibility level 3. This cannot be change without modification of the source code and re-compiling. This causes the blanking of the CMS when visibility falls below 100 feet that we observed during all serious fog activation events. This was apparently an oversight in the code that should be corrected.

Following our preliminary report and recommendations for immediate corrections in April 2004, District personnel devised a resourceful fix to this problem. Since recompiling the Signview source code was not an option, they reset the threshold for alarm level three on the QCMS computer to zero feet. This would leave alarm level two active all the way down to zero feet, and alarm level three would never be activated.
